THE LOWER RUSH RIVER

*PRESENT HEALTH
AND A CALL TO ACTION*

Prepared by Carl A. Nelson

October 22, 2019

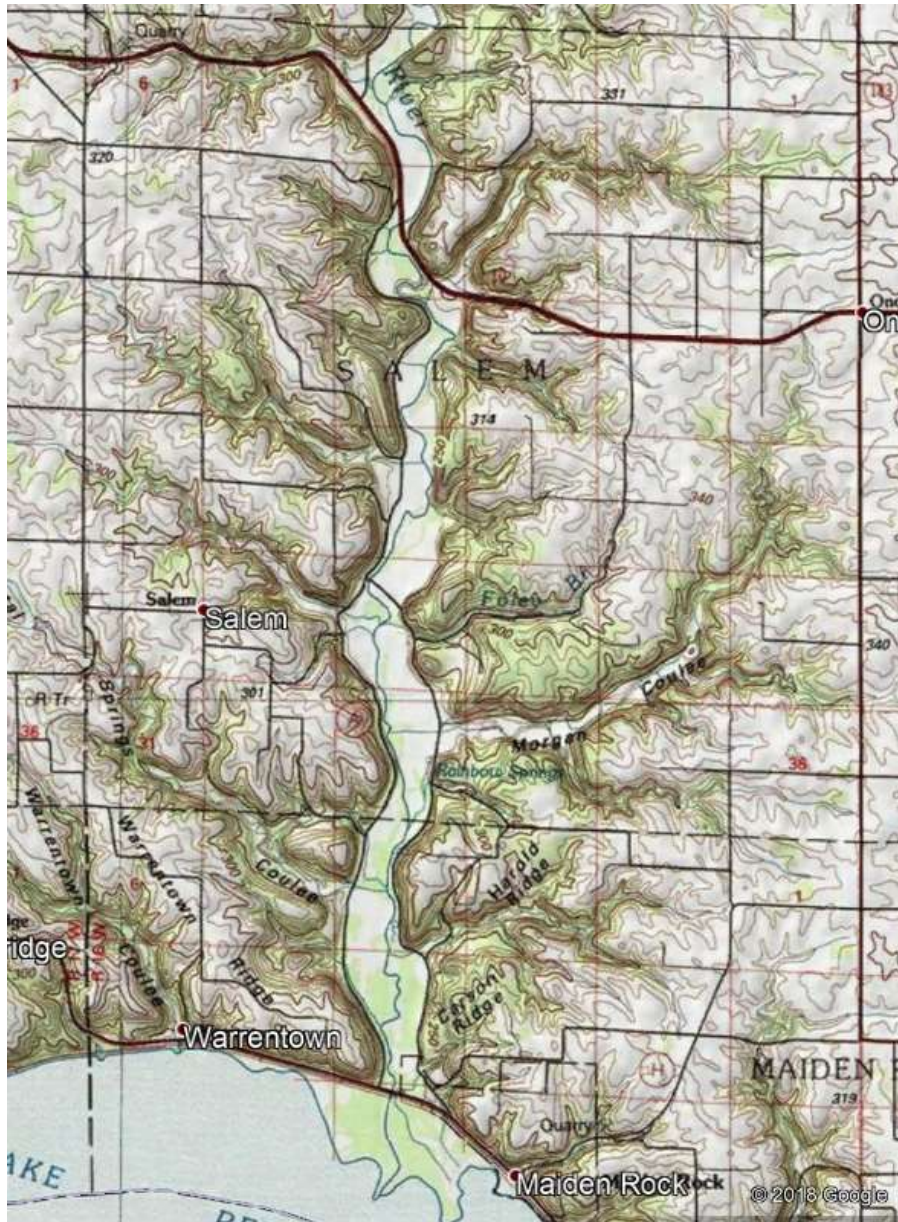
Figure 2. USGS topographic map of the Rush River. Heavy red line at top is State Highway 10.

The Rush and surrounding area are characterized by a rugged, well-drained topography and numerous cold-water streams and rivers, typical of the Driftless Area. This area is known for its thousands of miles of trout streams, many of them spring fed. Virtually all of these streams ultimately feed the Mississippi River. Figure 2 shows the USGS topographic map of the lower Rush. This clearly shows the highly dissected terrain, with many valleys (coulees) branching off from the river valley, often with further upstream branches. Some of these coulees have small spring-fed streams running year-round, while others have dry stream beds except during heavy rains and snow melt.

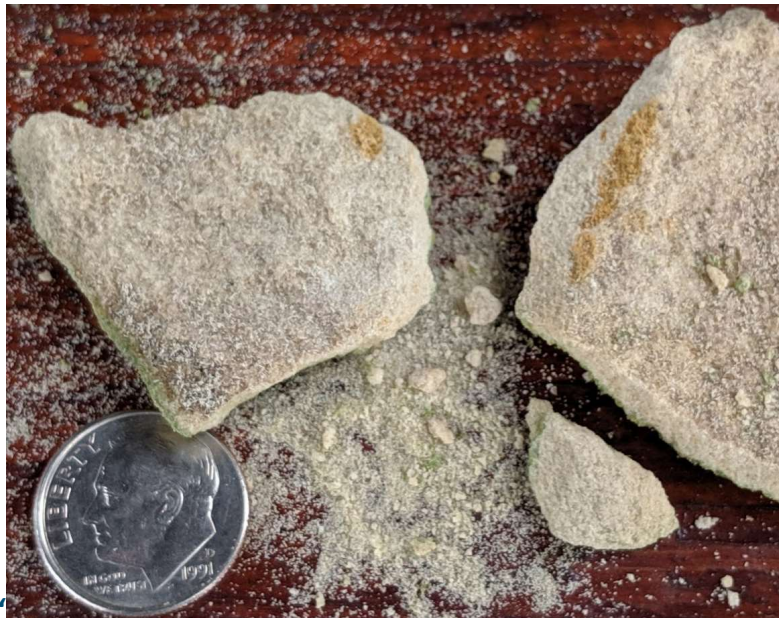
The Oneota dolomite is underlain by the Jordan sandstone, with a typical thickness of 25-35 meters (80-115 feet). It is generally found at the valley floor. Figure 3 shows an exposure of the Jordan sandstone at a roadcut near the Rush. As can be seen in the lower photo, this rock is friable and easily broken into grains by hand.

Figure 3. Exposure of the Jordan sandstone at a roadcut along 400th St., Salem Township. Rush River is just beyond the road. (Below) Piece of sandstone from this location.

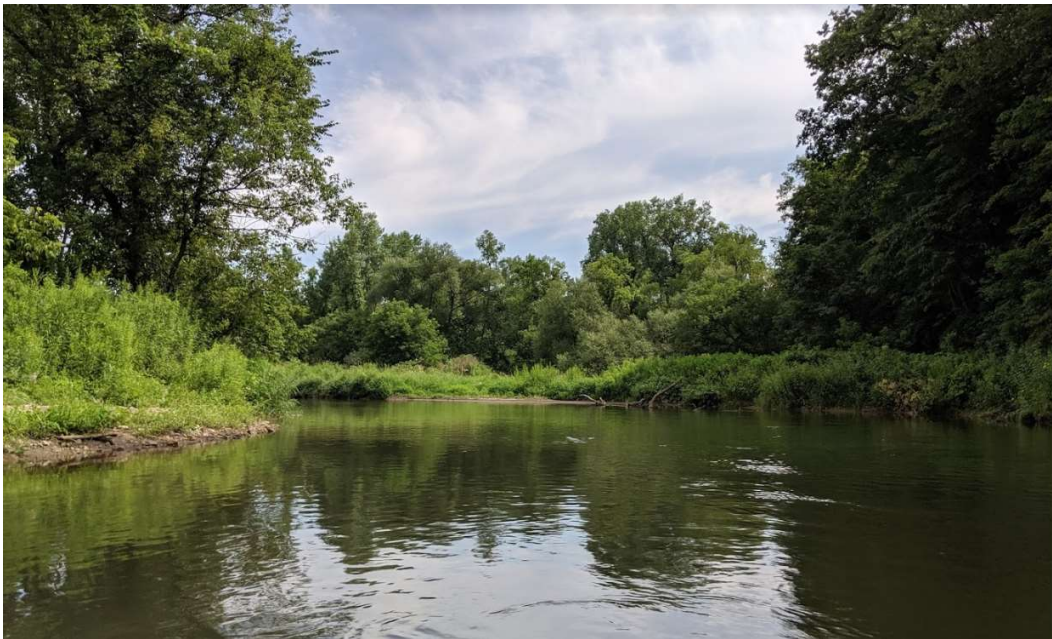
Figure 4. Typical stretch of the Rush above US 10 and below 450th Ave., El Paso Township Section 33 (July 2019).

As it enters its lower portion, the Rush River is a high-quality cold-water river. Lost Creek, the Rush’s largest tributary, joins the river just above 450th Ave in El Paso Township. Gravel and sand bars have historically been common in this area, providing good habitat for a variety of plants and animals. The stretch of the river just above Highway 10 is a popular destination for trout fishermen, as there are two bridge crossings which provide access to good trout water. Willows are abundant and provide good streamside cover and bird habitat. Figure 4 shows a typical stretch in this section of the river.

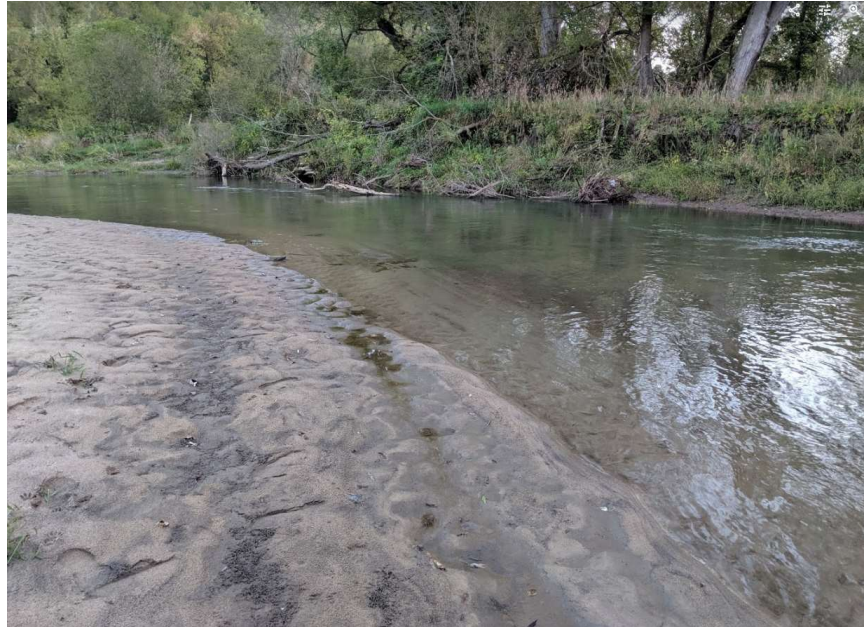
This process is playing out on the lower Rush today. Figures 6 and 7 (both taken July 2019) show two examples of the high bank-sandbar system, one from near the mouth of the river and one from much farther upstream. These photos illustrate the more silty (muddy) composition of the sandbars as the river delta is approached. The high-bank meanders will continue to develop as part of the natural evolution of the river system and adaptation to the aggraded “old” floodplain. Due to human activity, this process has been accelerated in some places by the planting of row crops on the river banks. Conversely, in other places the presence of roads and the use of rip-rap to stabilize high banks has temporarily halted the growth of the meander. However, large-scale stabilization of the river banks remains an expensive and difficult task, given the increasing frequency of extreme rainfall events.

Figure 6. Typical high bank with silty sandbar on opposite bank. Near boundary between Maiden Rock and Salem Townships, 3 miles from the mouth of the river.

The collapsing high banks continue to send sediment downstream, and this sediment is deposited along the last few miles of the river. As explained by Trimble (Ref. 1), the lowest stretch of Driftless Area rivers is generally a “zone of perennial sedimentation,” where continuous aggradation has taken place since shortly after settlement. This seems to hold true for the lower Rush. It is likely that the lowest stretch of the Rush will continue to aggrade in both the river bed and the floodplain, thus making this area significantly wetter as the river level rises.

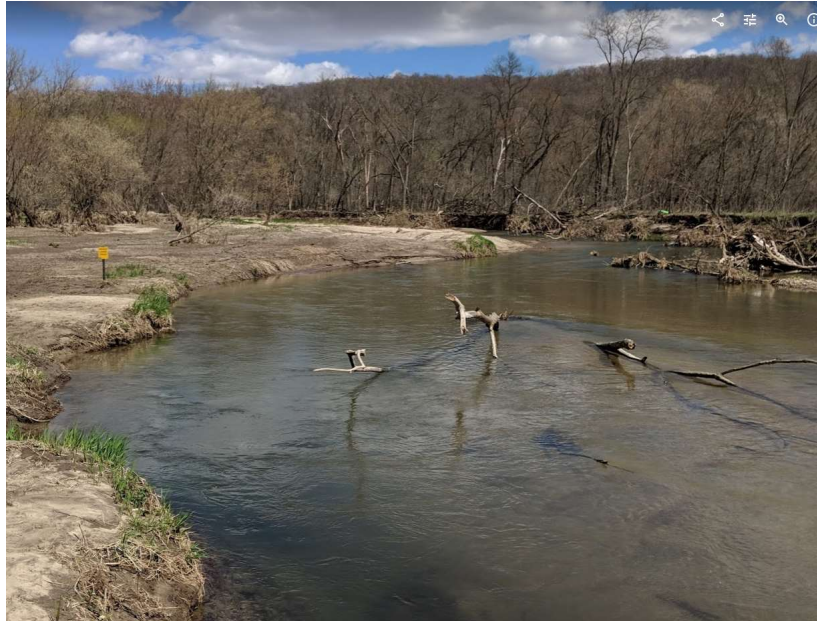
As a footnote, aggradation of the old floodplain—thought to have been virtually halted by measures taken in the 1930s—may be starting to re-occur. Figure 8 shows deposition of sandy silt on the high bank several feet above the normal river level. This photo was taken in April 2019 following heavy spring floods. The photo on the cover of this report was taken the same day at a location immediately downstream where the river “collides” with County Road A.

Figure 8. Sediment deposit during spring floods of 2019. Looking upstream from same location as report cover photo. Section 16 Salem Township.

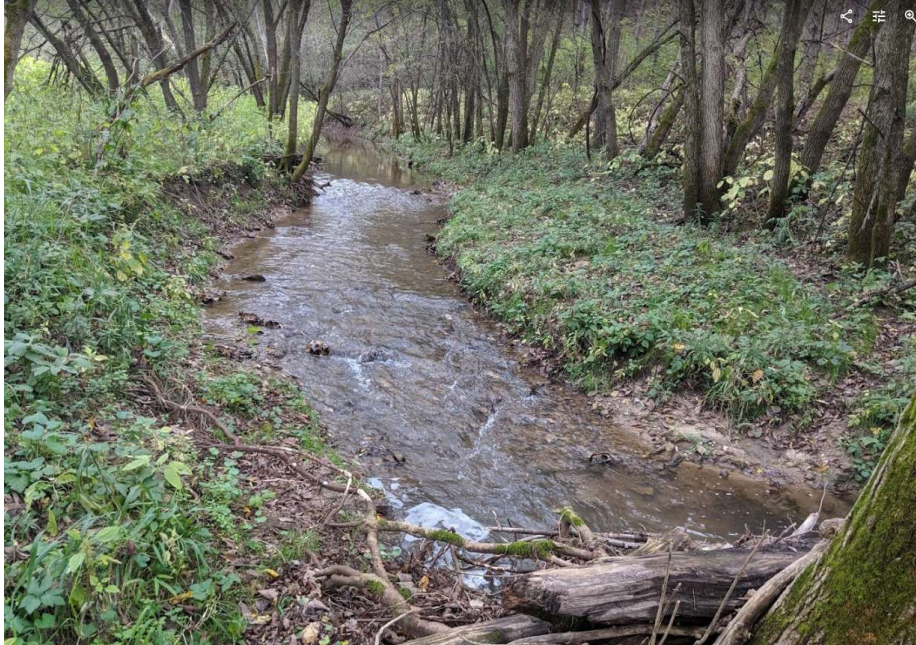
Figure 10. Morgan Coulee Creek. Photo taken in early October 2019.

Morgan Coulee Creek is a small tributary deserving of special mention. This spring creek is part of a rich complex of springs, creeks, and ponds located near the opening of Morgan Coulee into the Rush River valley. As seen in Figure 10, sections of this stream have been overgrown with boxelders—a common problem. Since this stream has a brook trout population and may provide spawning areas, water quality is a prime concern.

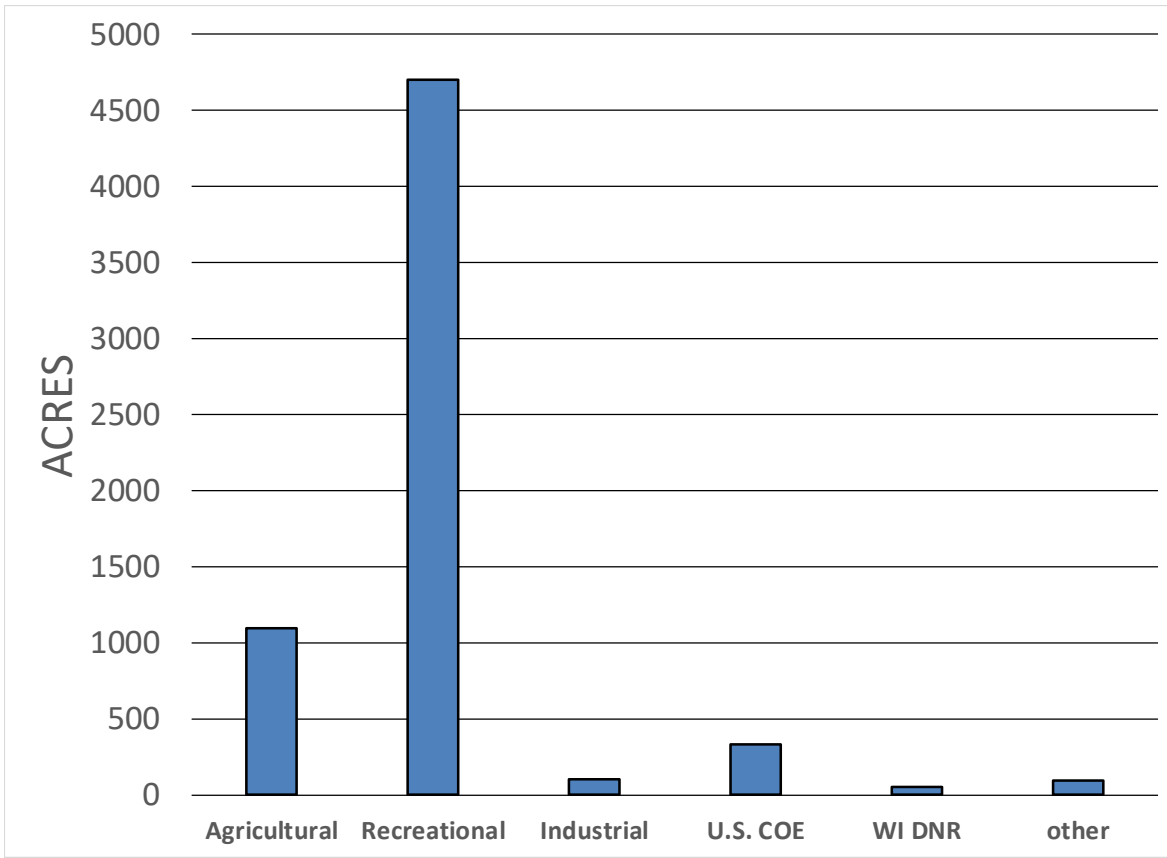
The figure below shows a rough breakdown of the land use by acreage, for the 10 sections (6400 acres) shown in the Appendix. Recreational land constitutes almost three quarters of the land, while agricultural land accounts for another 17 percent.

For this analysis, the land use in 10 sections was analyzed based upon satellite imagery. The 10 sections were conveniently chosen since the river lies entirely within this block. It should be noted that more than half of the area analyzed lies in the uplands on either side of the main river valley bottom. This can be clearly seen in the topographic map in the Appendix. If the analysis was repeated for the valley bottom only, the percentage of agricultural land would be somewhat higher.

Figure 11. Lower Rush River land use by acreage (Includes sections shown in Appendix.)

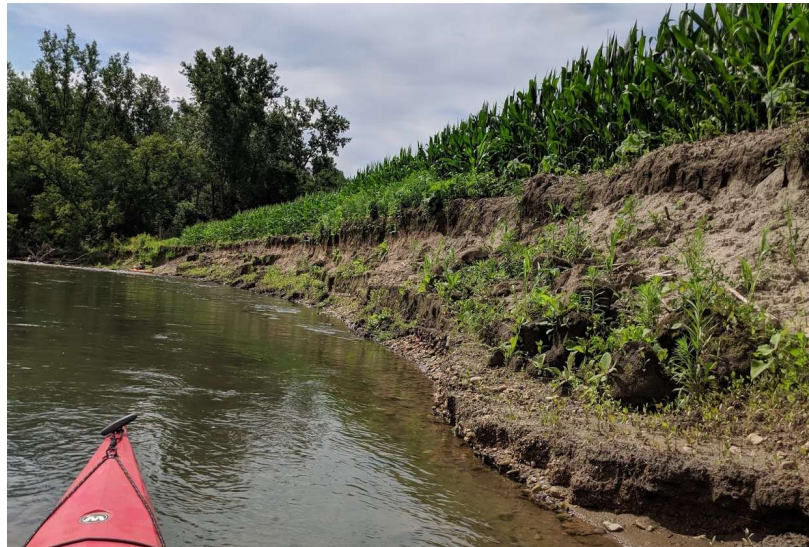
Figure 14. Corn field along the west bank of the Rush near intersection of Highway 10 and 400th Avenue (July 2019). (Bottom) Location of the top photo. Note frac sand on the right edge of satellite photo.

In general, the row crops are separated from the river by strips of trees, predominantly boxelder in the lower stretches of the river. However, a few fields are very close to the water's edge. An example of the consequences of corn on the river banks is seen in Figure 14. This field is located along the west bank of the river near the intersection of Highway 10 and 400th Avenue.

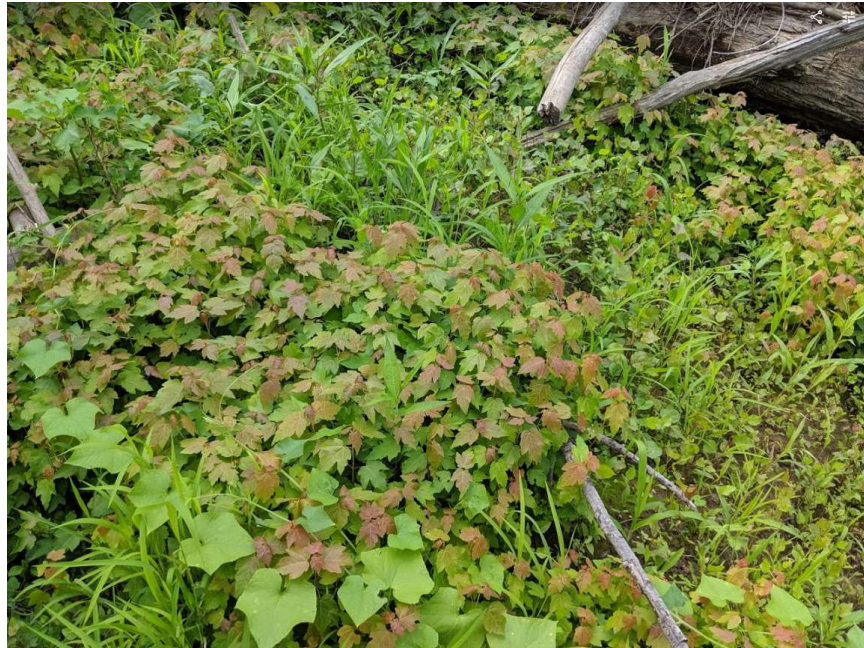
Figure 20. Silver maple seedlings growing on a log-jam island, Maiden Rock Township Section 9, one mile from the mouth of the river (July 2019).

On the floodplain and river banks, cottonwood, silver maple, and willow are common. These species are prodigious seed producers as well as very fast growers. Figure 20 shows the high density of silver maple seedlings that can be produced. These seedlings were found on an island just north of Highway 35 and west of the Maiden Rock sewage plant.

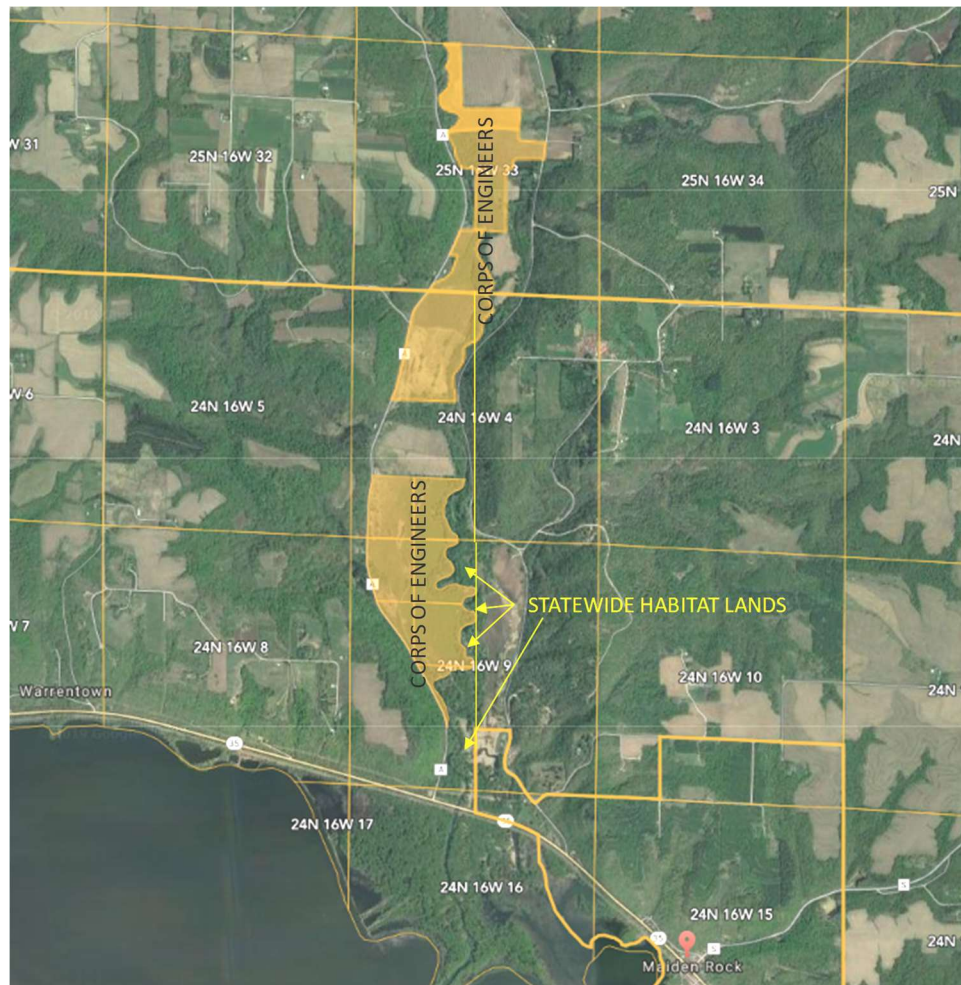
North of Highway 35 and extending up to Section 33 in Salem Township, large parcels of land are owned by the State and US government. Figure 24 shows the extent of these areas. Approximately 330 acres belong to the U.S. Army Corps of Engineers, and another 53 acres belong to the State of Wisconsin.

Figure 24. US government (Army COE) and State of Wisconsin-owned lands along the lower Rush.

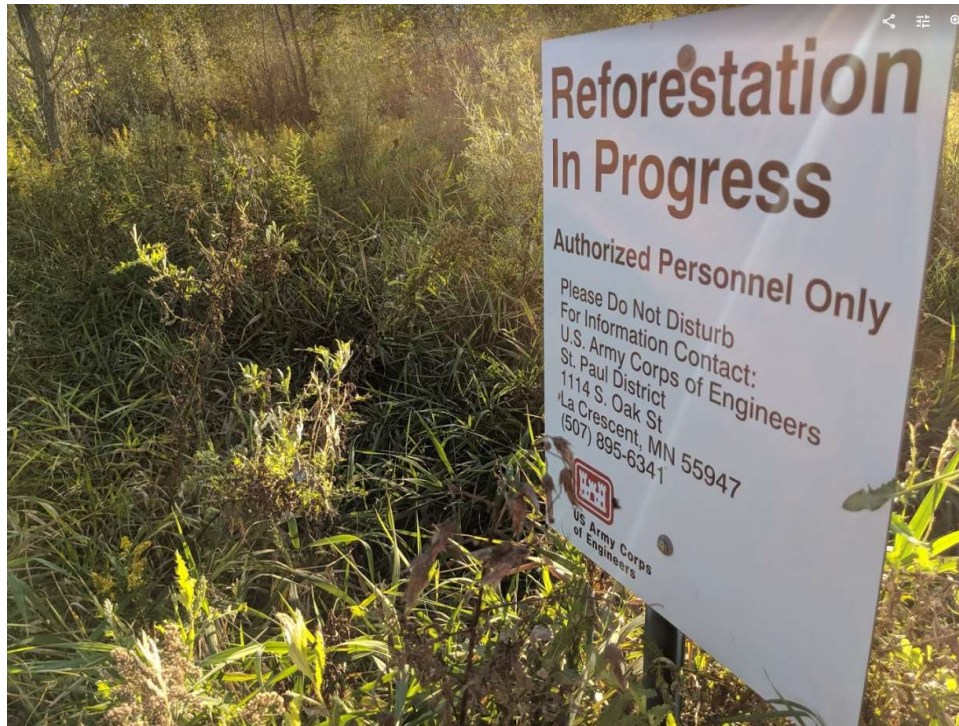
Figure 25. Wetland habitat on the US Army Corps of Engineers land (September 2019).

These extensive public lands north of Highway 35 encompass much of the floodplain downstream of Morgan Coulee, and comprise wet and seasonally wet grasslands, with scattered trees. Much of the area is covered with small cottonwood trees, with a thick groundlayer of reed canary grass. The area is well marked (Figure 25) as a reforestation area. On the positive side, there is great potential for enhancing the valuable wetland habitat with a variety of conservation measures. This topic is touched upon in the final section.

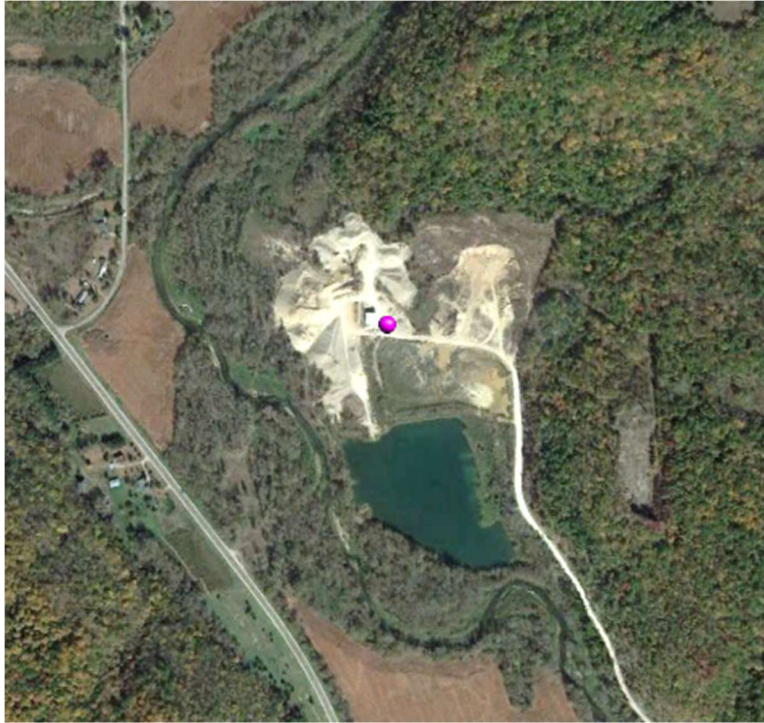
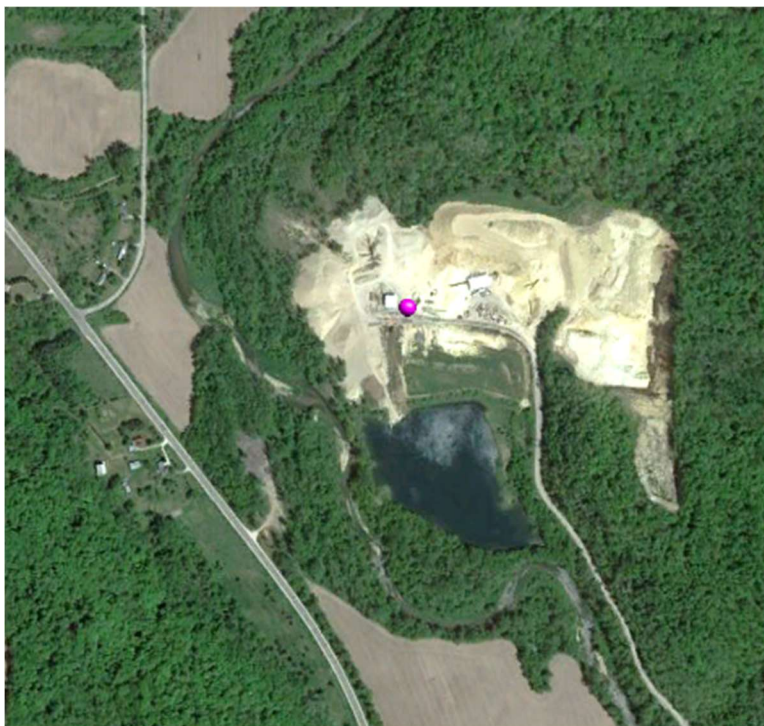
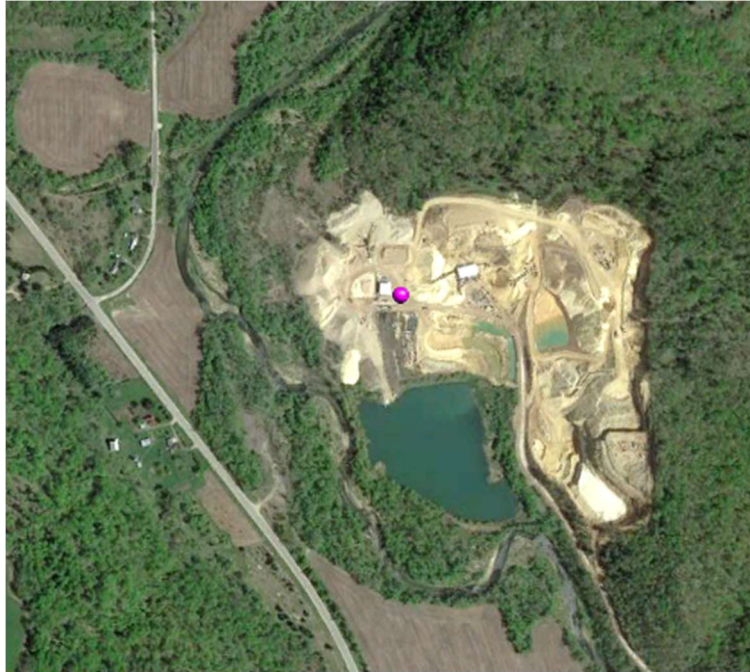
Figure 26 below shows the expansion of the mine beginning in 2012 through the most recent satellite image in May 2018. It can be seen that the area of the mine has approximately doubled over that time, with more than 20 acres added to the east. More importantly, the volume of material removed has been enormous, due to fact that the added area has been from a hillside with an elevation at least 200 feet over the adjacent river valley. It is estimated that at least 4 million cubic yards of earth have been removed, and the once heavily wooded hillside, which included remnant white pines as well as hardwoods, is now gone forever. Figure 27 shows a topographic map with contours superimposed on the mine footprint.

Figure 26. Progression of the excavation into the wooded hillside for the frac sand mine just north of Highway 10.

Figure 26 (cont.) Progression of the excavation into the wooded hillside for the frac sand mine just north of Highway 10.

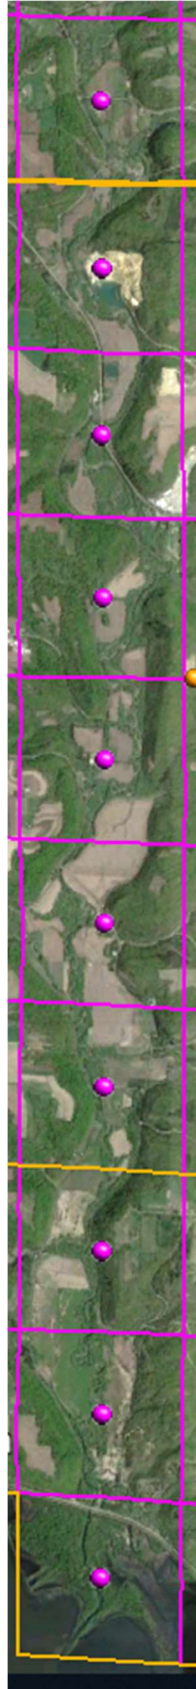
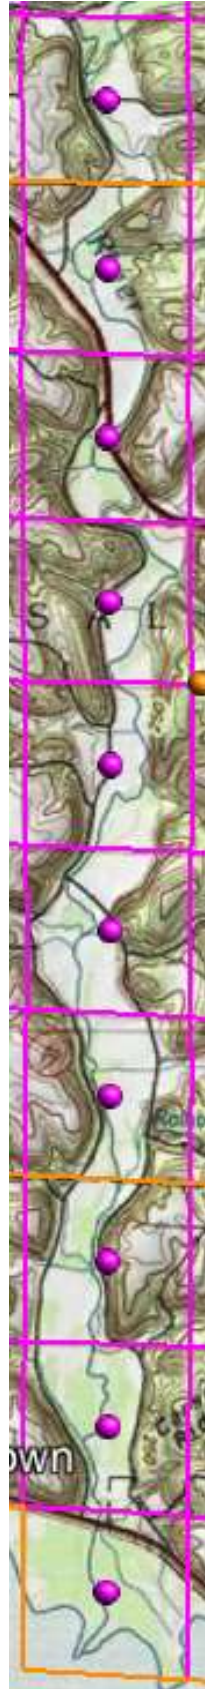
Sections Used for Land Use Analysis (Figure 11)

From Top to Bottom: El Paso Sect. 33, Salem Sects. 4,9,16,21,28,33, Maiden Rock Sects. 9,16
